POL PIER REPAIRS
LAJES FIELD, AZORES

CONSTRUCTION INSPECTION VISIT NO. 3
SEPTEMBER 25 TO OCTOBER 3, 1980

CONTRACT NO. N-62477-79-C-0021
MODIFICATION P-00001

OLKO ENGINEERING
CONSULTANTS • DESIGNERS

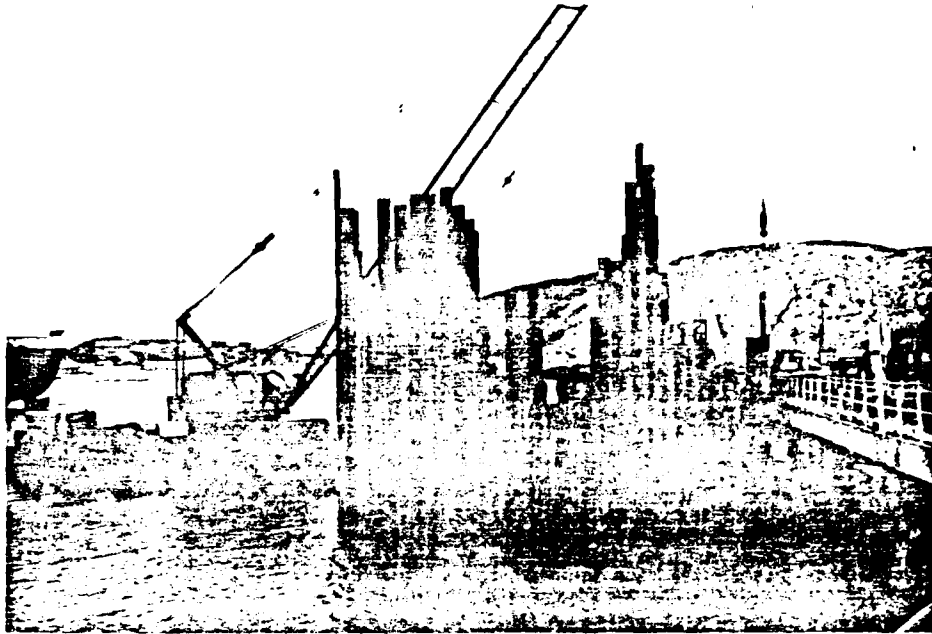
NEW SOUTH DOLPHIN

Overall View, Looking North. The North, East and South Walls Are Partially Driven. The South End of the East Wall Is "Hung Up" on an Obstruction About 5 Feet Below the Harbor Bottom.

at an angle. However, questioning could not confirm who had identified the obstruction, or the certainty that it was a pile. Nevertheless, dives have been made and since the upper sand in the harbor bottom is very loose, the divers were able to dig under the steel sheets and feel the tip end of the obstruction. During the visit, there were discussions about removing the obstruction, jetting, etc., but nothing was done. The Contractor attempted to organize divers, obtain firehose for jetting, but this did not materialize. There were equipment breakdowns, etc. and coordination problems which prevented work. It is understood that this hung up sheeting has existed since mid-September. Nothing was done to correct it, since the 100-Day Pier Shutdown Period was coming to a close and the Contractor believed they would not be able to operate because of the scheduled ship berthings. However, the berthings did not materialize and, in hindsight, it would have been possible to remove the obstruction and continue with driving the east wall of the cell.
